Re: September 2012 Monthly Progress Report
Administrative Settlement Agreement and Order on Consent for Removal Action
U.S. EPA Region 10 Docket No. CERCLA 10-2009-0255
Gasco Sediments Site within the Portland Harbor Superfund Site

Attachment A Monthly Visual Monitoring Report for Pilot Cap Vicinity

Visual Observations Log Form

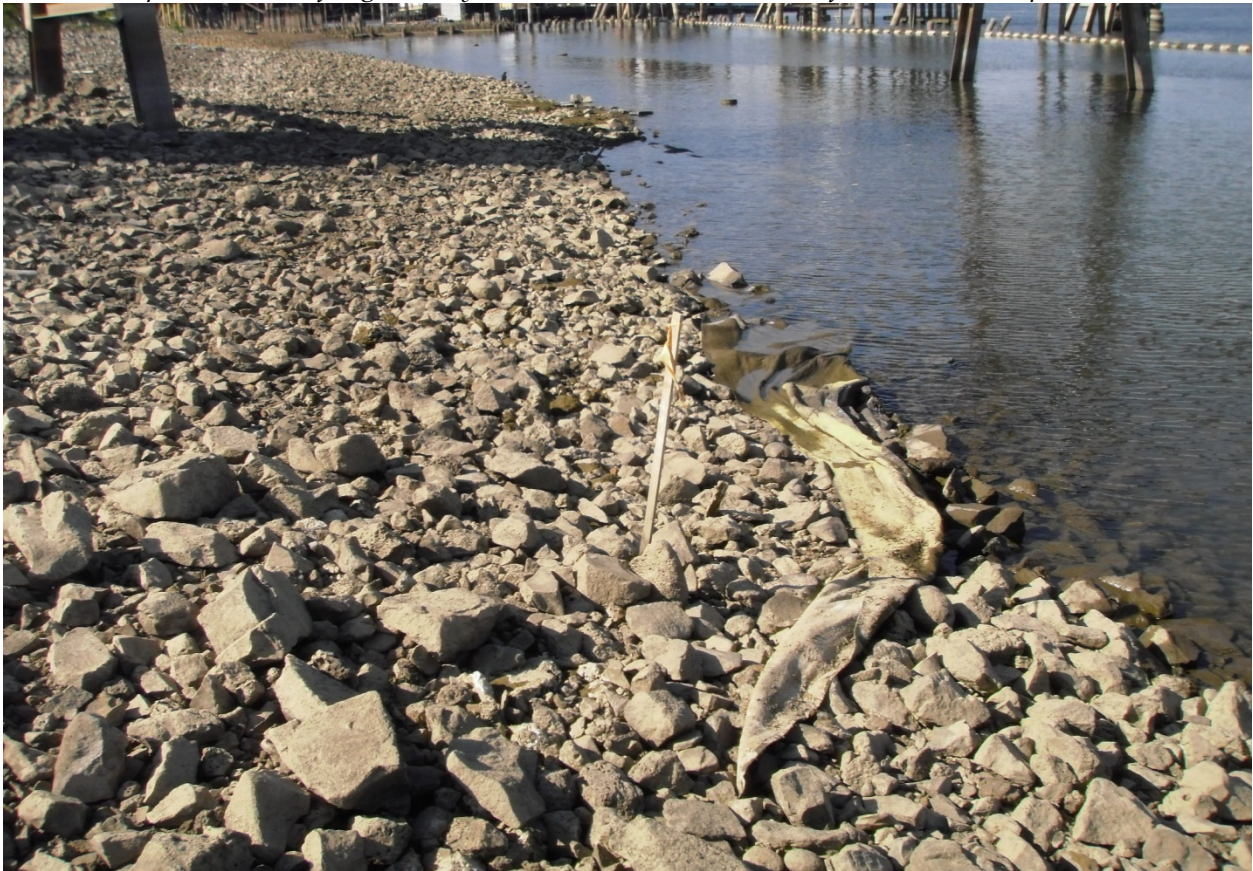
Observations of Erosion/Deposition:	No erosion/deposition is evident along the shoreline. Four organoclay mat material segments are exposed and visible. One 20-foot section of organoclay mat is visible at the upriver extent of the cap area. Two segments measuring 4-foot and 2-foot in length are exposed approximately 6 feet from the water's edge near the lateral mid-point of the cap area. One 40-foot section of organoclay mat material is exposed near the downriver extent of the cap area vertically to the shoreline (Photo 1).
--	---

Photo 1- *Exposed section of organo-clay mat at the downriver extent of the sediment cap (9/26/12):*

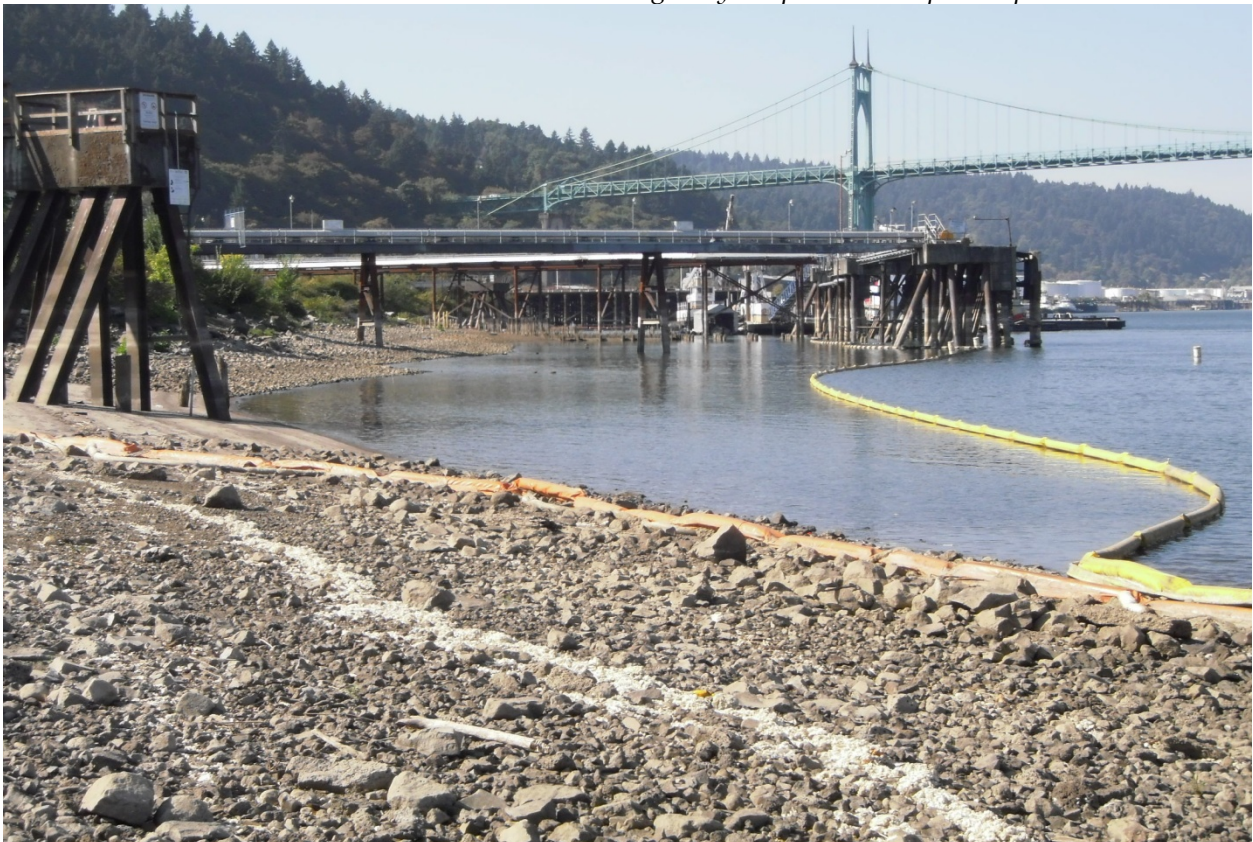
Observations of Long-term Controls (i.e., oil booms, organo-clay mat, etc.)	During the observation, the Fuel and Marine Marketing (FAMM) containment boom was in place across the cap area, between the upriver corner of the ship dock and the wooden dolphin (near the upriver extent of the site and near the Siltronic Corporation outfall). Buoys that identify the cap area to mariners are in place as installed. The position of the FAMM oil boom, warning buoys, and a general overview of the site shoreline is shown in Photo 2.
--	--

Photo 2 - *FAMM oil boom shown and mariner warning buoys in place across pilot cap area. (9/26/12):*

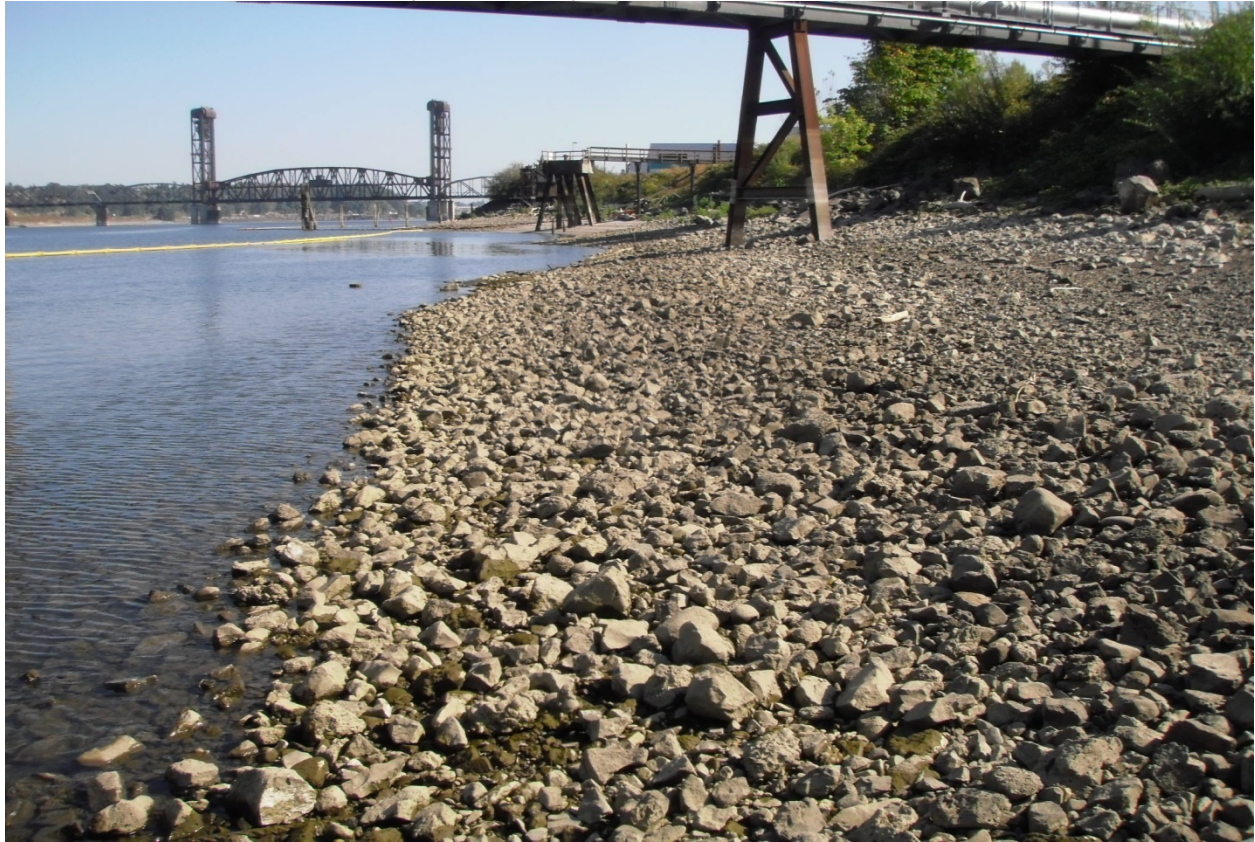
Other Comments:	No sheen is evident in or around the cap area. Photo 3 shows the water surface and shoreline immediately downriver of the sediment cap.
------------------------	---

Photo 3 — *Conditions immediately downriver of cap area (9/26/12):*
